HOME REPORT

Energy Performance Certificate (EPC)

1F3 , 263 LEITH WALK, EDINBURGH, EH6 8NY

Single Survey

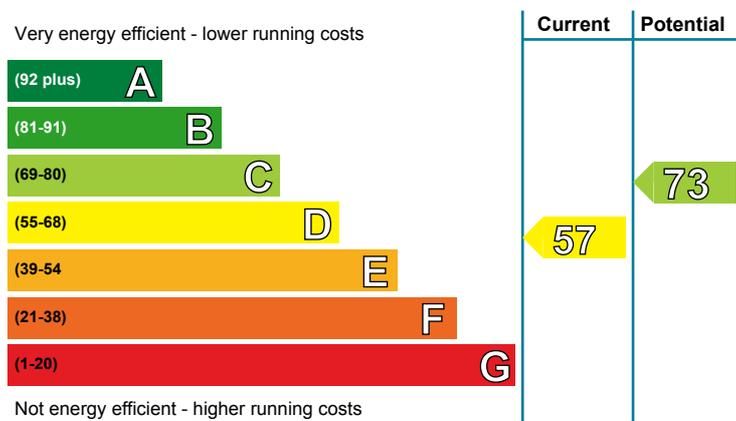
Energy Efficiency Rating

This graph shows the current efficiency of your home, taking into account both energy efficiency and fuel costs. The higher this rating, the lower your fuel bills are likely to be.

Your current rating is **band D (57)**. The average rating for EPCs in Scotland is **band D (61)**.

The potential rating shows the effect of undertaking all of the improvement measures listed within your recommendations report.

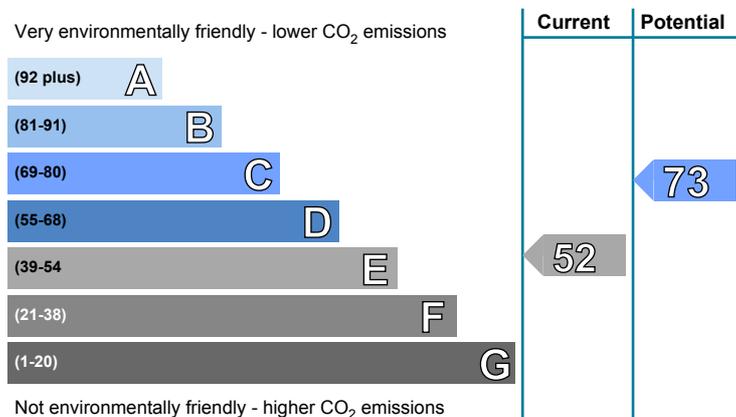
Environmental Impact (CO₂) Rating

This graph shows the effect of your home on the environment in terms of carbon dioxide (CO₂) emissions. The higher the rating, the less impact it has on the environment.

The potential rating shows the effect of undertaking all of the improvement measures listed within your recommendations report.
